This is a brief extract from a
23 page Residential Building Survey
undertaken in late 2010.

3.00 ROOFS, CHIMNEYS AND RAINWATER FITTINGS:

**A GLYN JONES RESIDENTIAL BUILDING SURVEY OF:
A South Warwickshire Cottage**

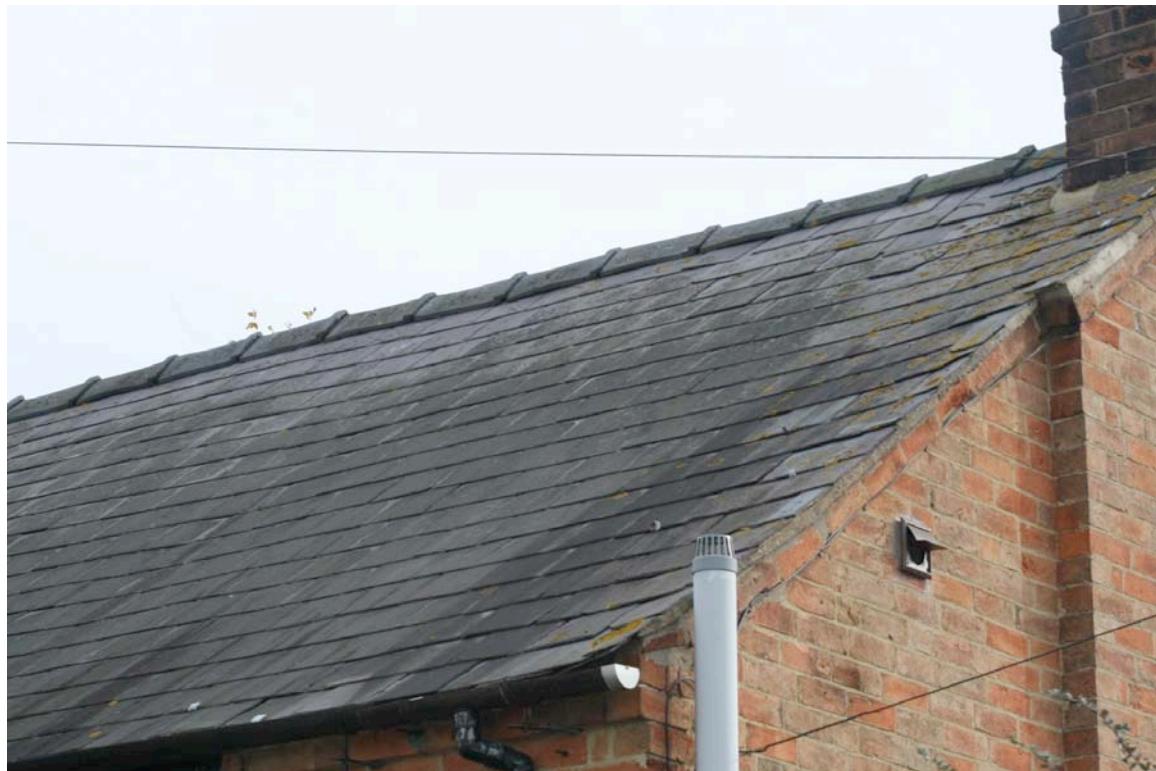
On the front face of the roof, there are about half a dozen cracked, dislodged or missing slates, by the right hand chimney. (See Photograph Nos. 1 & 3). There is a similar number of broken and dislodged slates by the left hand chimney. (See Photograph Nos. 2 & 4).

**PHOTOGRAPH NO. 1
Front face of main roof**

It is apparent, from the foregoing, that the roof has reached the end of its life. Although it will be possible to repair the roof, by replacing the broken and missing slates, further slippages of slates are likely to occur and the need for repairs will be a perpetually ongoing process. In the circumstances, you should give consideration to stripping off and re-slating the roof. A specification for this and the associated repairs follows:-

- 1) Instruct a competent roofing contractor to:
 - a) Erect scaffolding against the exterior of the building, to enable safe access.
 - b) Strip off the existing slate coverings and carefully remove the solar panels.
 - c) Remove the existing tile battens.
 - d) Strengthen the roof frame, by removing the existing timber purlins and replacing them with larger ones.
 - e) Felt over the roof rafters.
 - f) Re-batten the roof.
 - g) Re-slate the roof.
 - h) Remove the existing cement flaunchings into the two chimney stacks and replace with stepped lead flashings and soakers, suitably dressed into the stack brickwork.
 - i) Take off and re-bed the pot on the left hand chimney.
 - j) Provide ridge tiles suitably pointed.
 - k) Clean out the roof space and insulate to modern standards.
 - l) Provide covers and insulation to the water tanks.
 - m) Replace the metal rainwater fittings with new.

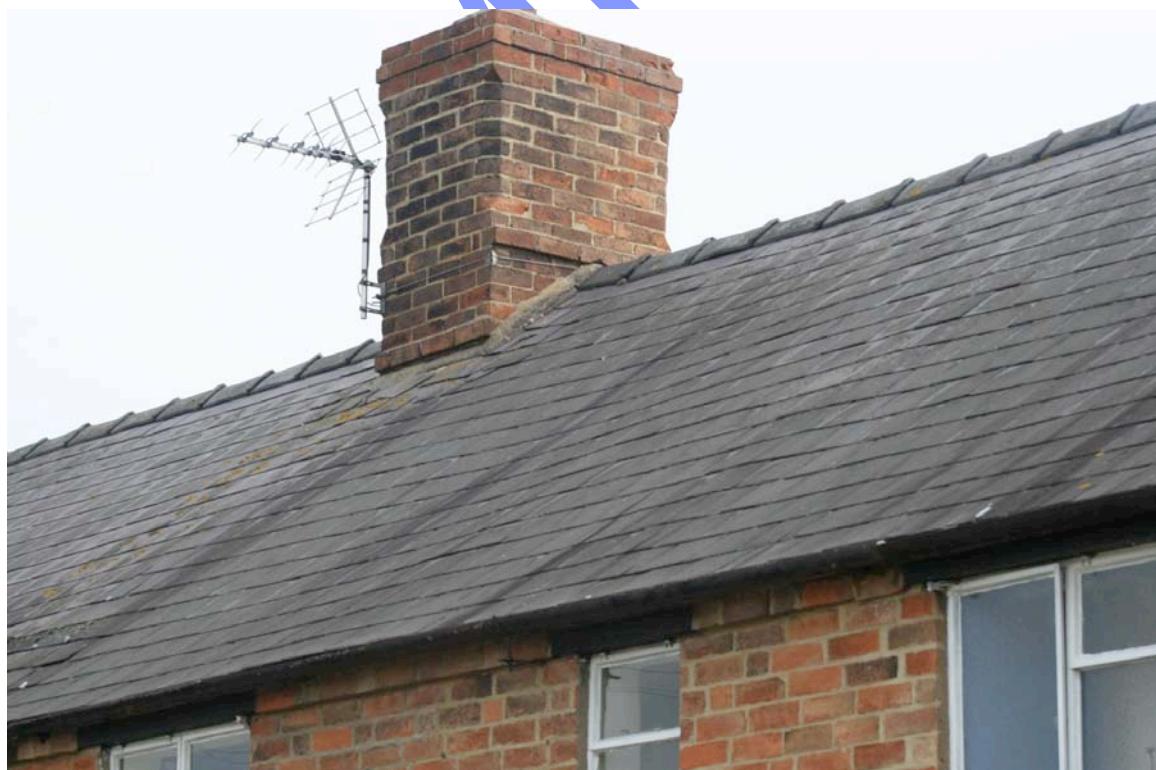
There is evidence of distortion in the roof, where the slate covering sags and undulates. This is particularly noticeable on the front face of the roof, left hand side. (See Photograph No. 2). The distortion is caused by the fact that irregular shaped timbers have been used to frame the roof. There has also been some slight distortion in the timbers, although the evidence of this is old. My advice is that, when the roof is stripped off and re-slated, additional support is provided, in the form of larger timber purlins.

**PHOTOGRAPH NO. 2
Front face of main roof**

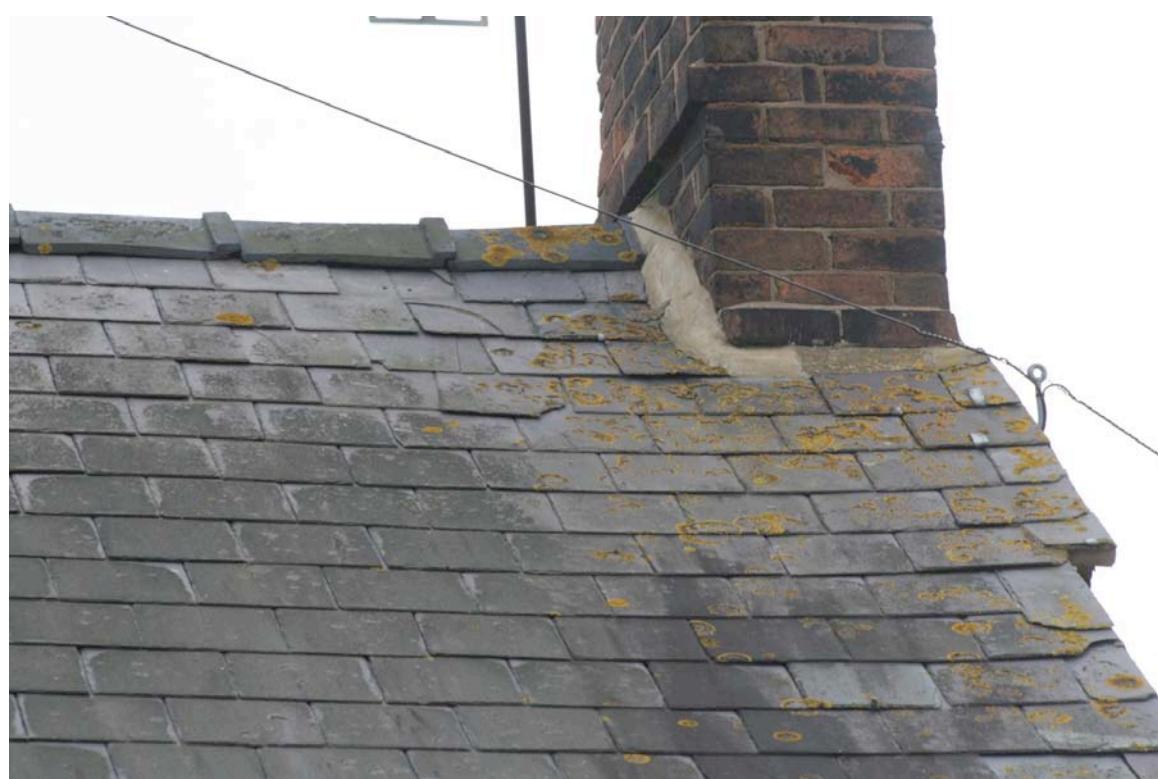
**PHOTOGRAPH NO. 3
Broken slates on front roof**

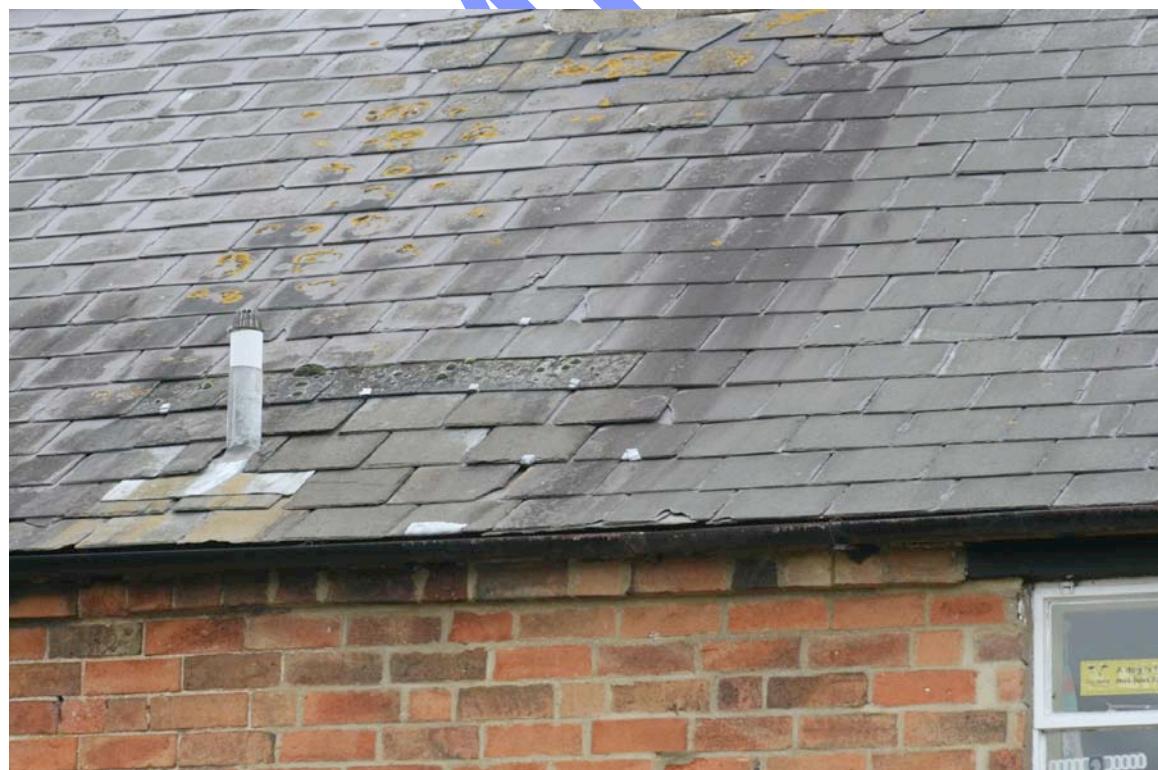
**PHOTOGRAPH NO. 4
Broken slates on front roof**

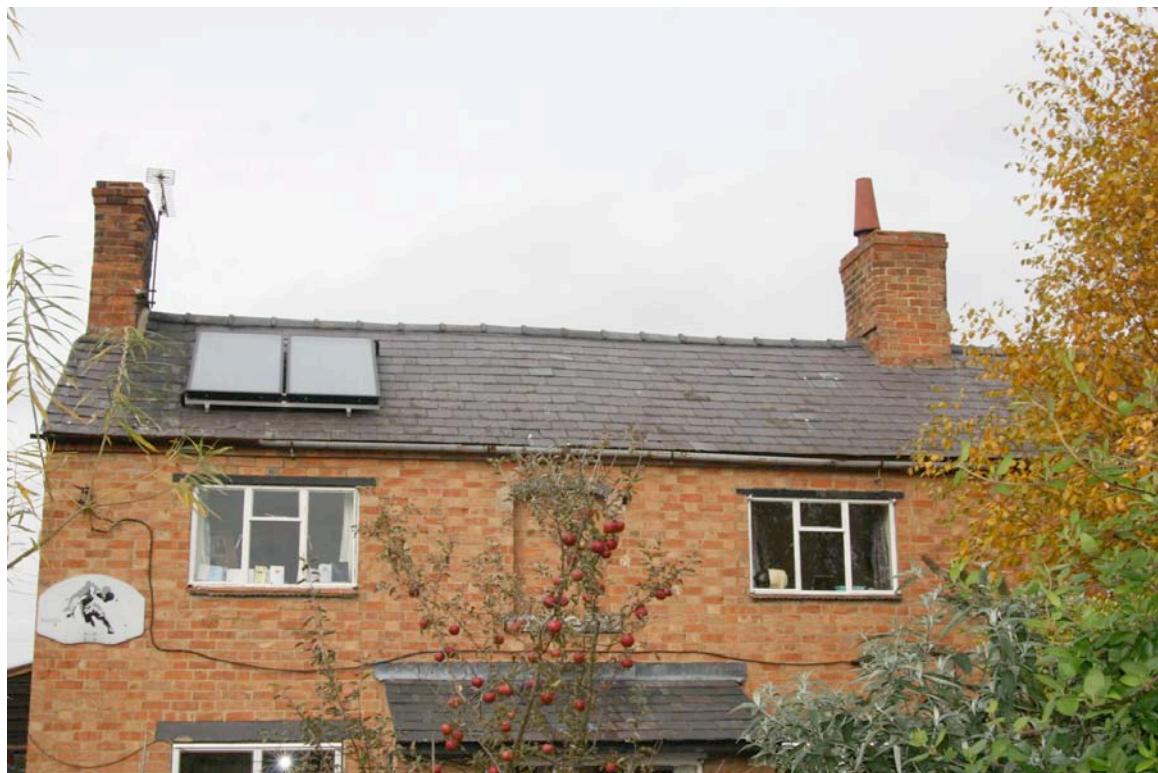
**PHOTOGRAPH NO. 5
Rear face of main roof**

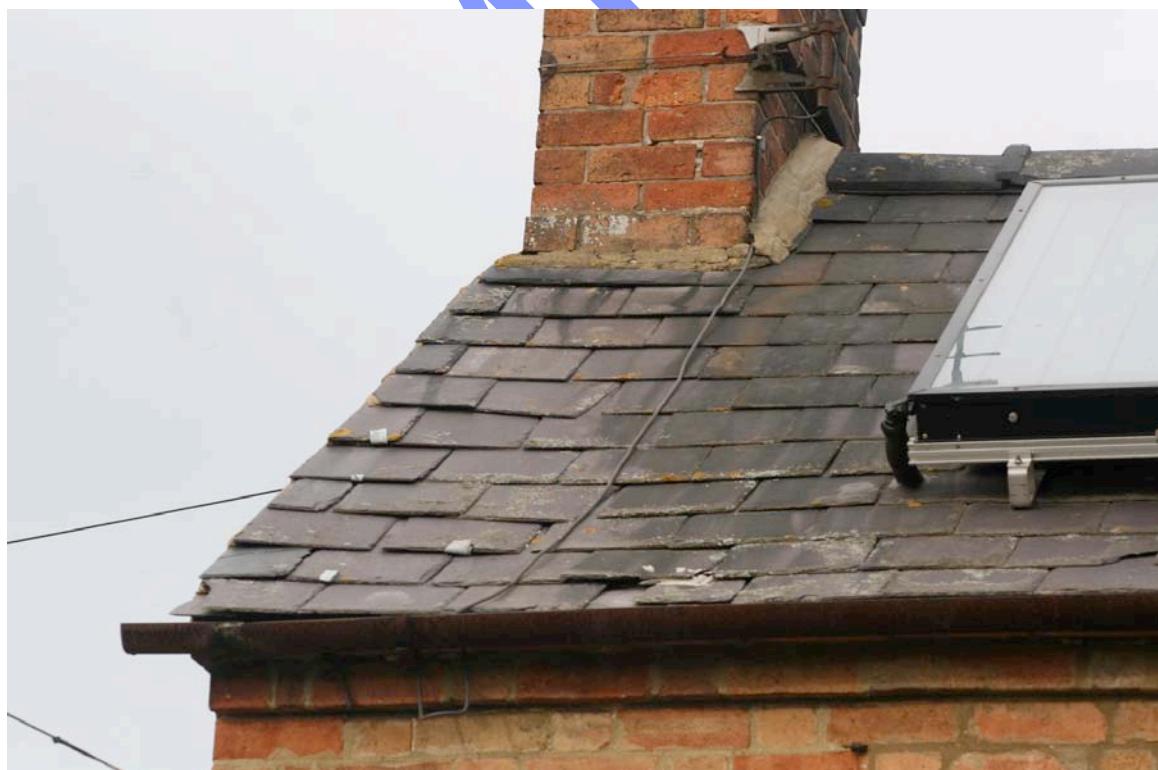
On the rear face of the roof, there are some dislodged slates by the eaves and evidence of previous repairs, where lead straps have been used to re-fix slates. (See Photograph No. 6).

**PHOTOGRAPH NO. 6
Broken and repaired slates on rear roof**

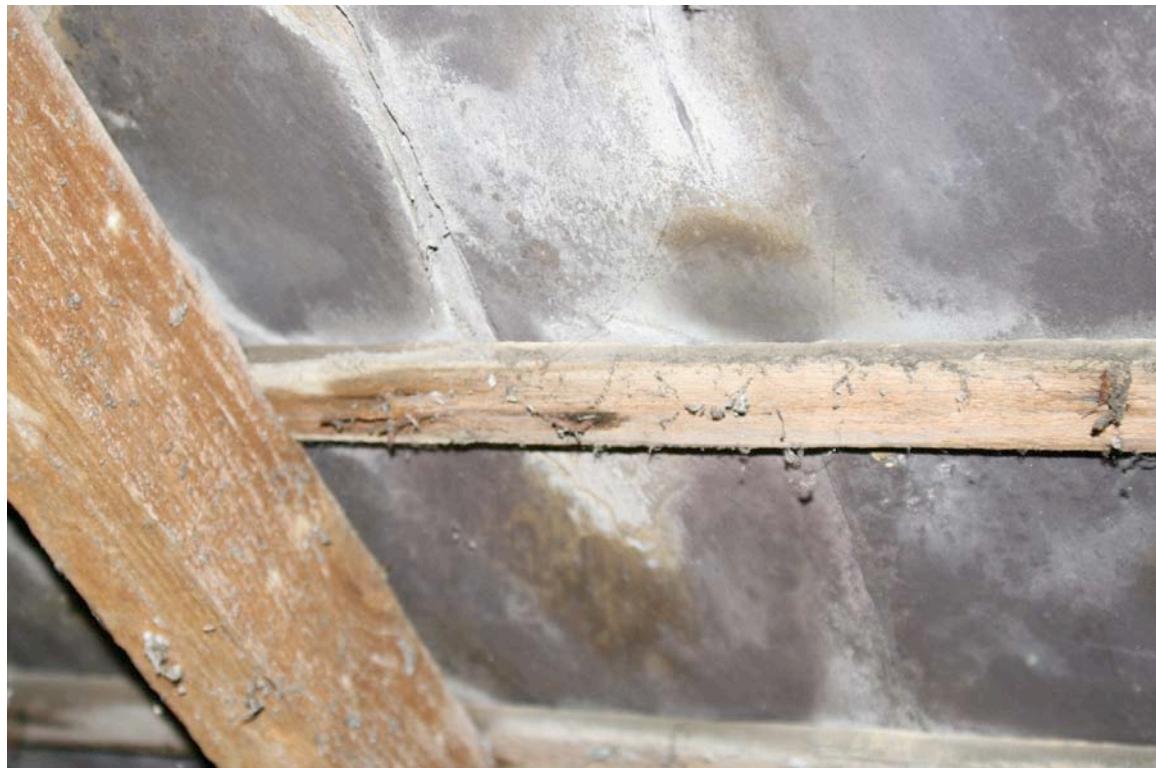
During my examination of the roof space, I saw daylight in a couple of areas, where slates are broken or are missing from the roof. I also noted that the nails, which fix the slates to the timber tile battens, have rusted and failed. The underside of the slates has perished and the timber tile battens have split. (See Photograph Nos. 7 & 8).

PHOTOGRAPH NO. 7
Taken in roof space - rusty nails fixing slates

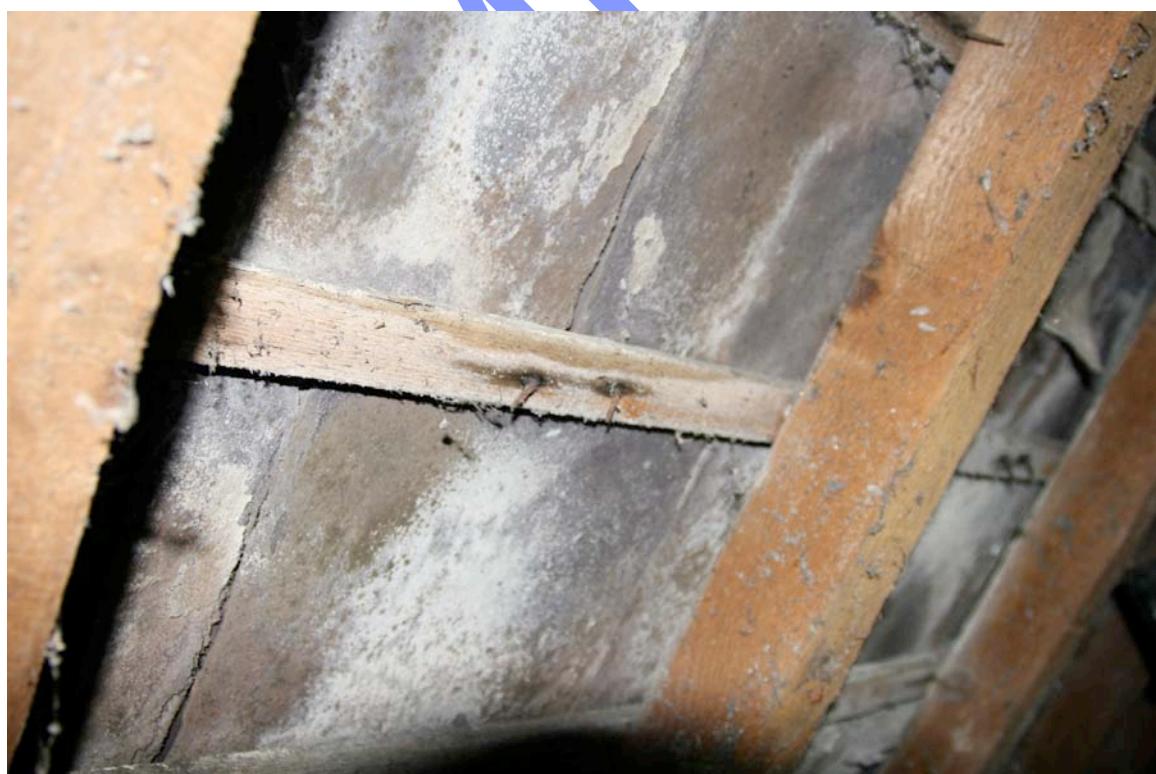
PHOTOGRAPH NO. 8
Taken in roof space - rusty nails fixing slates
