This is a brief extract from a 30 page Commercial Building Survey undertaken in 2010.

4.04 External Windows:

A REPORT ON THE GENERAL CONDITION OF: A Warwickshire Pub		
5.01	Clean the kitchen floor tiles and replace the cracked tiles. Repaint the concrete floor in the wash up area.

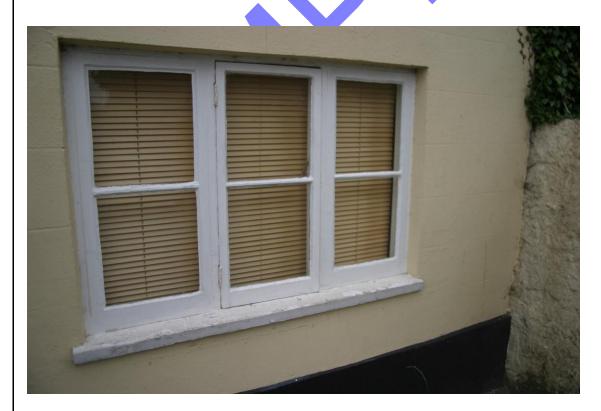
The windows in the front and rear walls comprise, painted timber frames. They are in reasonable condition, although the paint is peeling from them externally. The opening lights in these window frames are likely to be draughty and a source of heat loss.

The external decorations are fair only. The render on the front wall is soiled and the paint is peeling from the timber window frames. Re-painting of the exterior will be required, before too long. It is normal for Commercial Leases to prescribe a regular interval for re-painting of the exterior. You should, via your Legal Advisers, ascertain when this is next due. A specification for repainting follows:-

Photograph No. 212. Paint peeling from lounge bar window

- 1) Instruct a competent decorator, with the aid of scaffolding erected for render repairs to:
 - a) Rub down and remove all loose and flaking paint.
 - b) Re-paint the woodwork, using two undercoats and one top coat.
 - c) Re-paint the render, using two coats of good quality masonry paint.

4.08	Redecorate externally. Rub down and remove all loose and flaking paint. Re-paint the woodwork, using two undercoats and one top coat. Re-paint the render, using two coats of masonry paint.

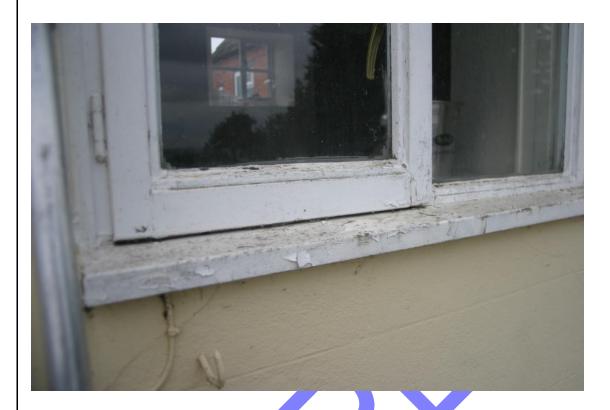
Photograph No. 215. Paint peeling from landing window

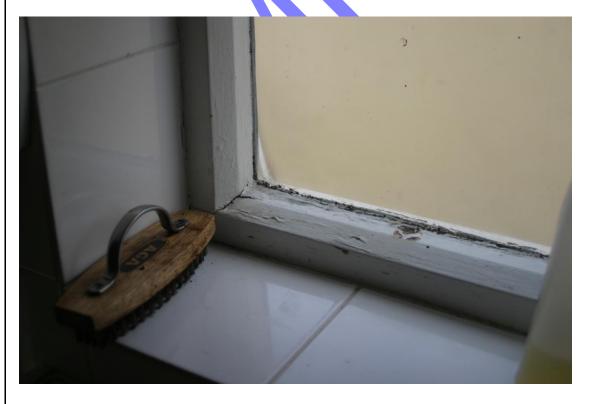
It is apparent that some of the frames have been previously patched, using filler. I found extensive rot on the inside of the kitchen window frame. (See Photograph No. 217).

Photograph No. 217. Rot inside the kitchen window frame

- 1) Instruct a competent joiner to:
 - a) Check each of the timber frames and overhaul, as necessary, prior to re-painting.
 - b) Replace the rotten kitchen window frame.

4.02	Carry out plastering of the walls in the bar area affected by rising damp i.e. the chimney breast, left hand side and the pillar, by the bar.
4.05	Check and repair all window frames, prior to re-painting. Replace the rotten window frame in the left hand wall of the kitchen.
