## 1.00: INSTRUCTIONS:

In accordance with verbal instructions, I have been asked to advise upon structural movement in the above property.

**A GLYN JONES STRUCTURAL APPRAISAL OF:  
A property in Banbury Oxfordshire**

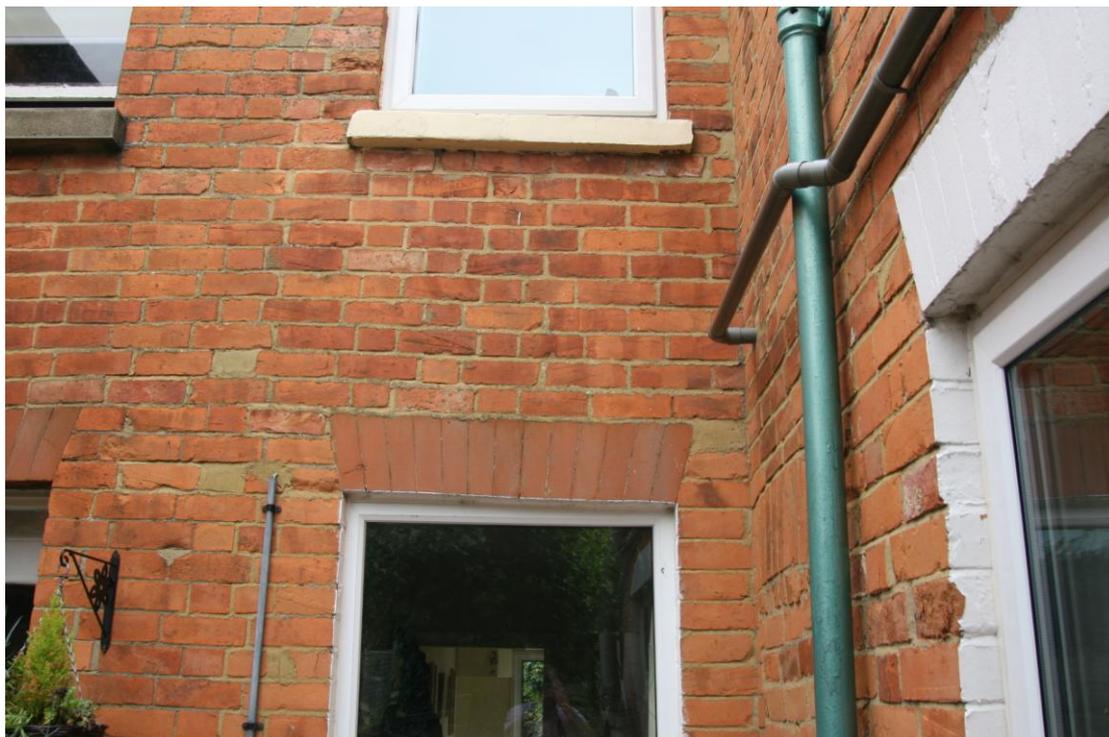
In the main rear wall, the bedroom and dining room window openings are not truly horizontal; the heads and sills in these openings slope down from right to left. (See Photograph Nos. 8 - 12). However, the evidence of movement is clearly old.

**PHOTOGRAPH No. 9 - Distortion in the window openings**

The house is about 120 years old. There is evidence of old movement in the structure, where the heads and sills in the rear window openings have distorted; the upper part of the rear gable wall has distorted slightly and the apex section of this wall bulges outwards slightly. This movement in these areas is clearly old and the situation is now stable.

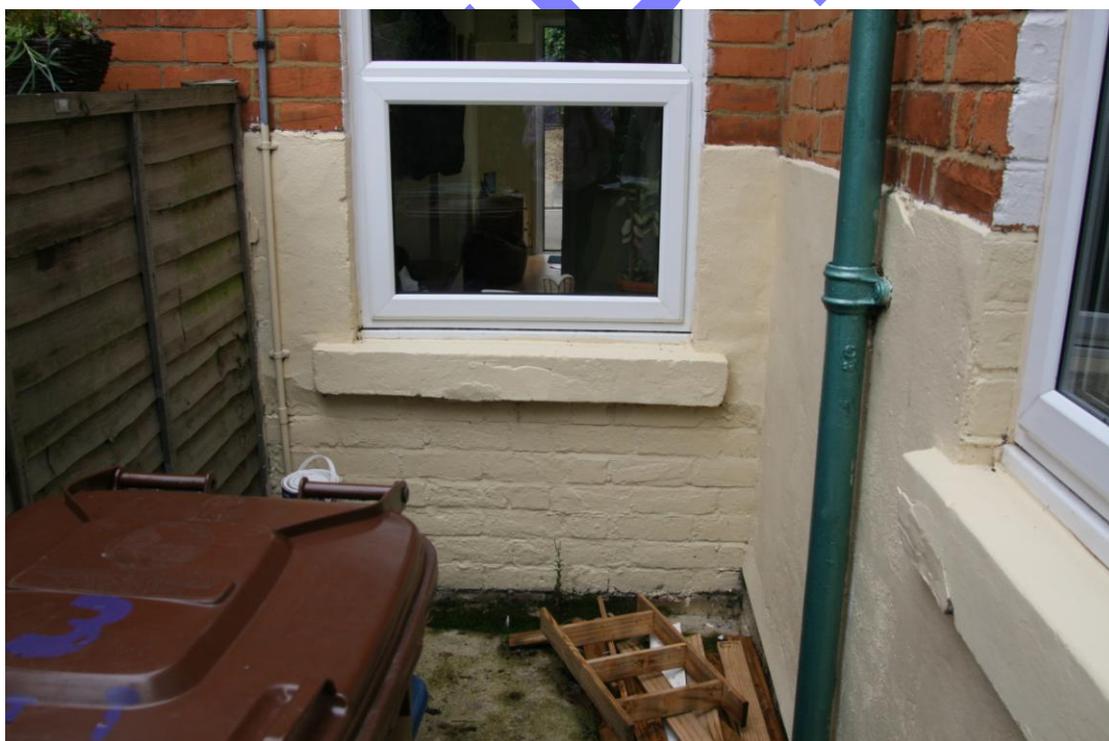
**PHOTOGRAPH No. 10 - Distortion in the window openings**

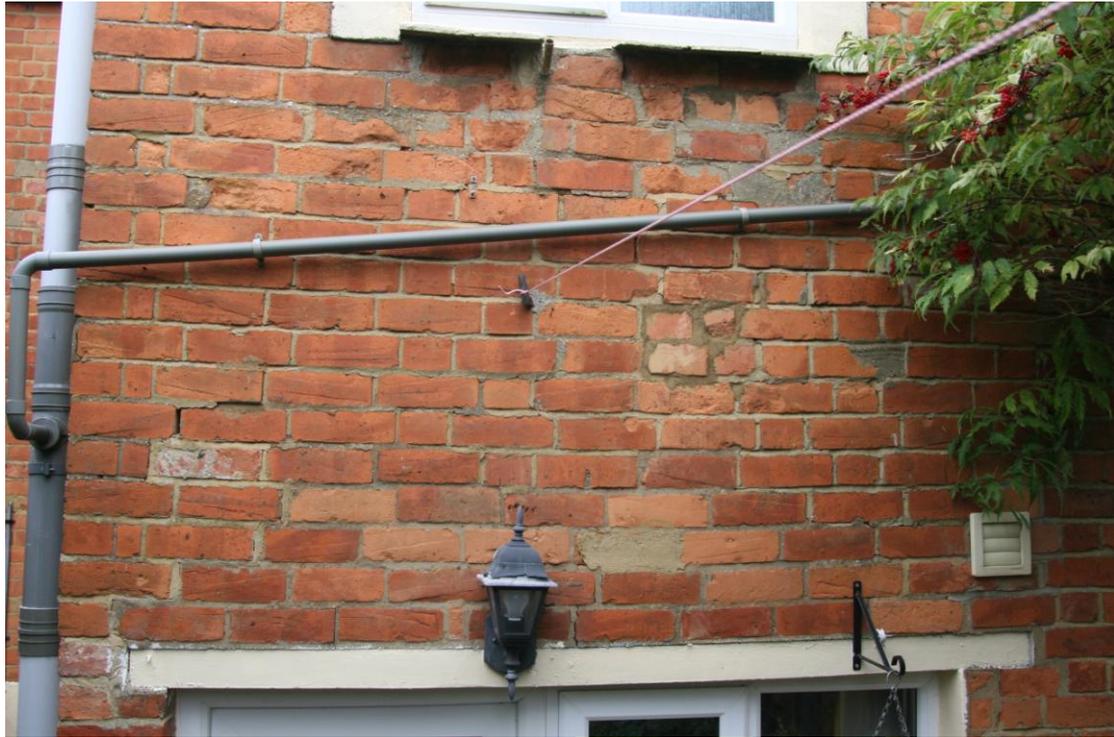
The timber lintel sags slightly and there are cracks in the mortar joints above it. These cracks are between 1mm and 3mm in width. There are old infestations of woodworm in the timber lintel, although it is free from rot. (See Photograph Nos. 20 - 38).

**PHOTOGRAPH No. 20 - Distortion above the kitchen window**

The cracking and distortion above the outer kitchen door/window opening has been caused, I believe, by the creation of the new opening. The cracking is likely to have occurred soon after this work was undertaken. The cracks are "slight" and no signs of **significant** recent or ongoing movement were observed. Although the timber lintel has sagged, it is structurally sound.

My advice is that the cracks externally are cut out and properly filled and a suggested specification for this follows:-

- 1) Instruct a competent bricklayer to:
  - a) Cut out the mortar from the cracks.
  - b) Fill the masonry cracks, using epoxy resin anchor grout.
  - c) Re-point the cracks, using and cement mortar

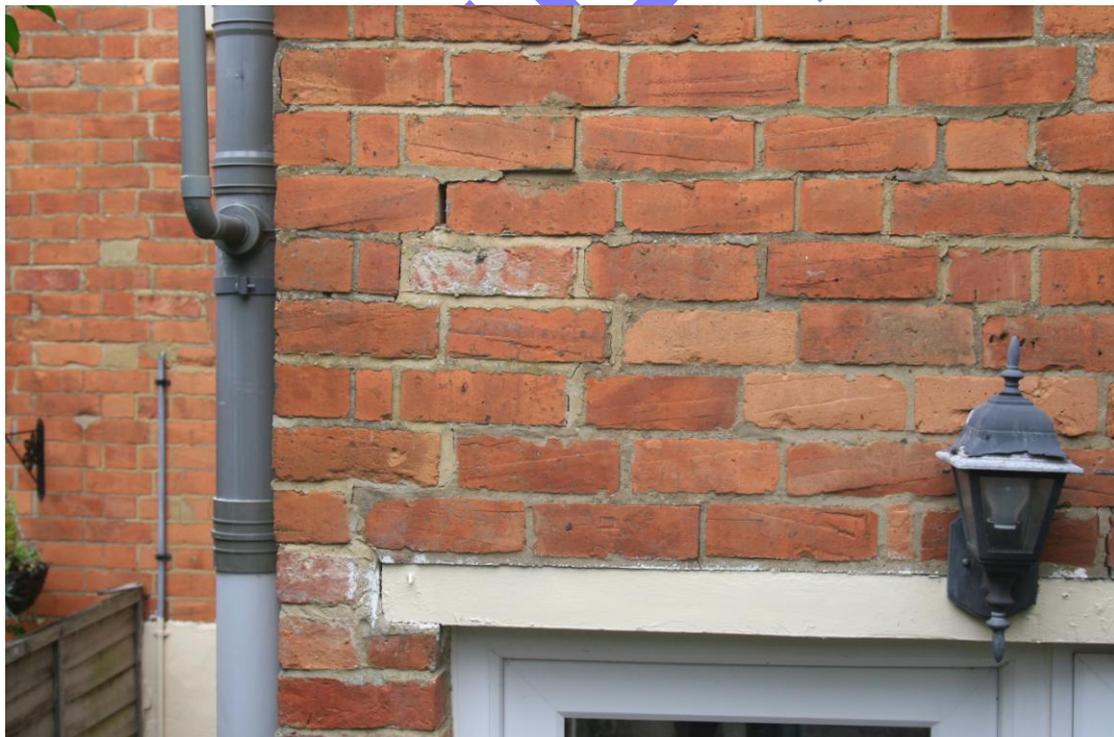
**PHOTOGRAPH No. 22 - Cracking above the kitchen window/door**

It is common practise to categorise the structural significance of damage in buildings, in accordance with a classification given in Table 1 of Digest 251 produced by the Building Research Establishment. In this instance the cracks are between 1mm and 3mm in width; they, therefore, fall within the category of "**slight**".

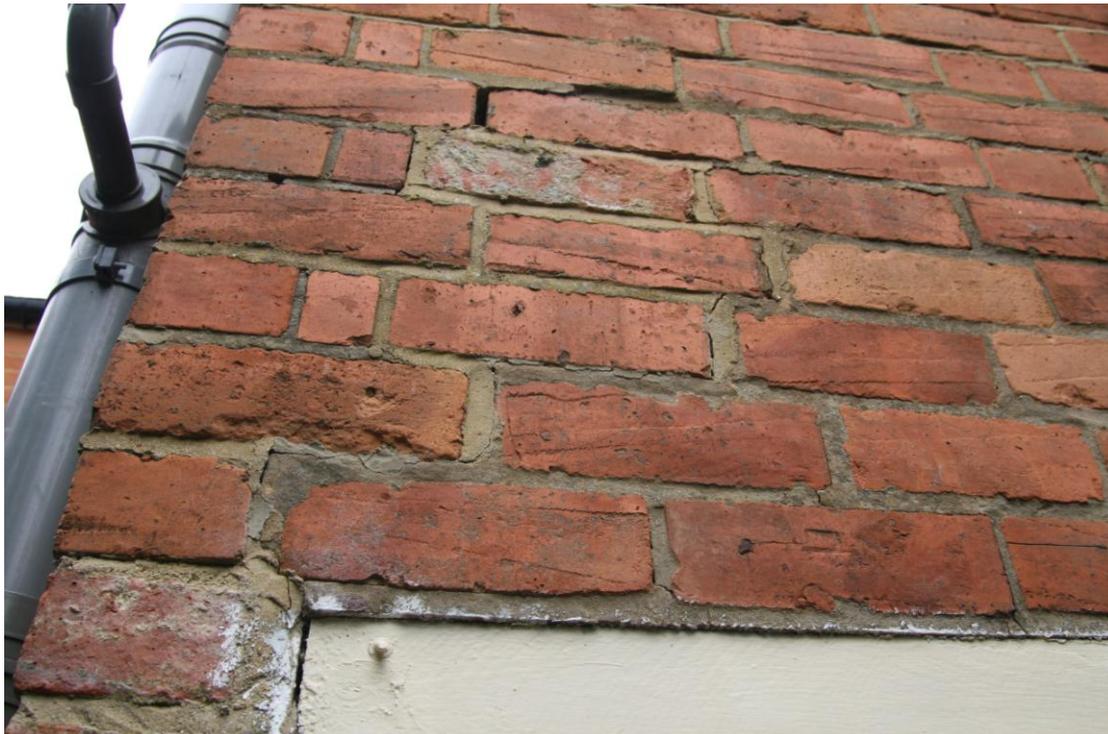
**PHOTOGRAPH No. 24 - Cracking above the kitchen window/door**

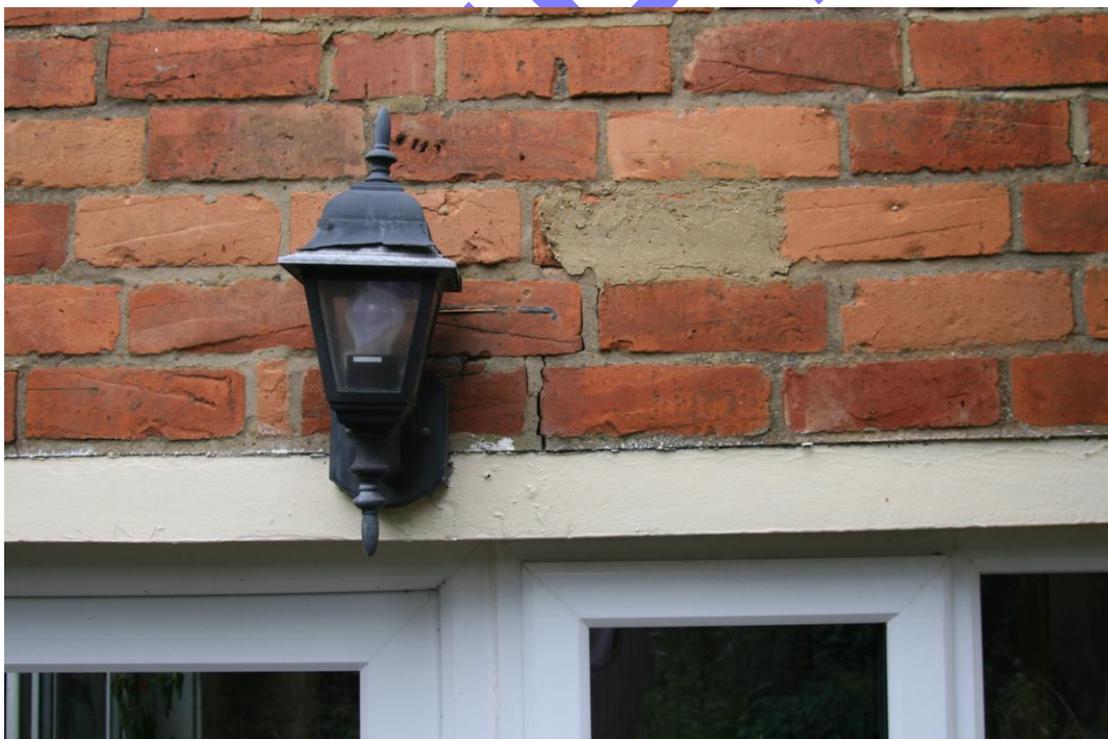
**PHOTOGRAPH No. 25 - Cracking above the kitchen window/door**

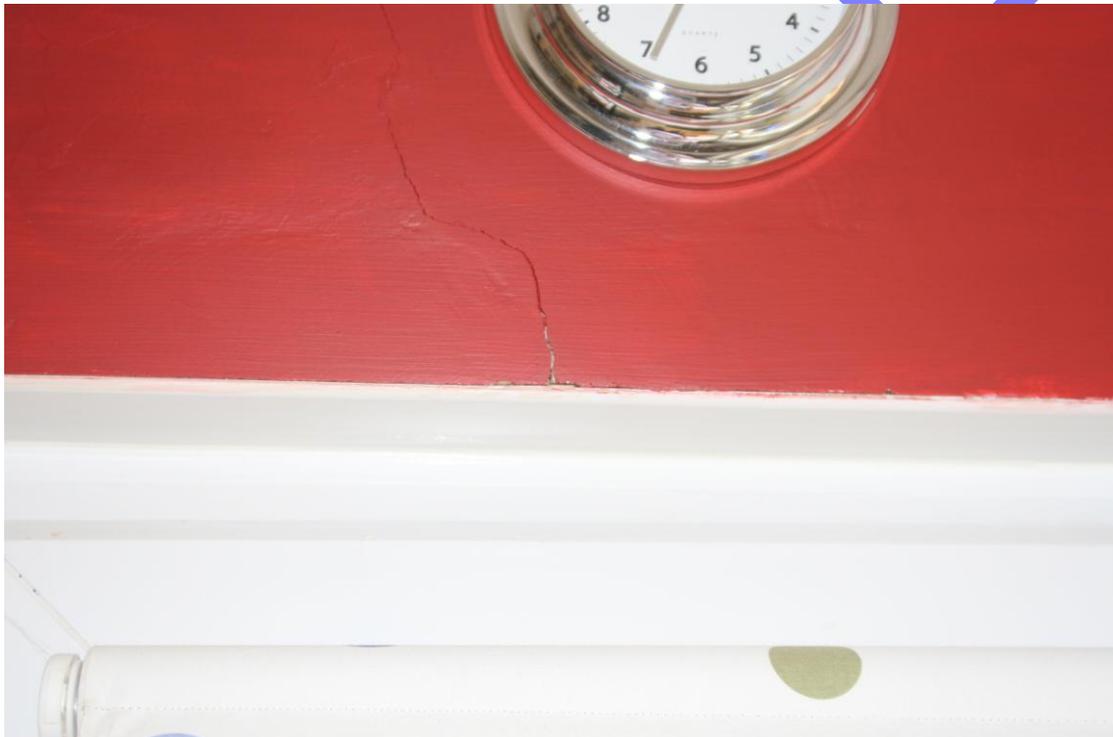
In the rear wall of the kitchen, there is a zig-zag, diagonal, crack in the plaster above the outer door opening. (See Photograph Nos. 39 - 41). The crack is about 1mm in width.

**PHOTOGRAPH No. 41 - Plaster crack above the kitchen door**

The plaster cracking internally should also be repaired and a specification for this follows:-

- 2) Instruct a competent plastering contractor to:
  - a) Remove the plaster from the rear kitchen wall, above the outer door opening.
  - b) Fill any cracks in the masonry behind, using epoxy resin anchor grout.
  - c) Fix expanded metal lath over the cracks.
  - d) Re-plaster the wall internally.
