**A Glyn Jones Homebuyer Survey of:
A detached bungalow in Mount Nod Coventry**

**This is a brief extract from an
18 page Homebuyer Survey
undertaken in late 2010.**

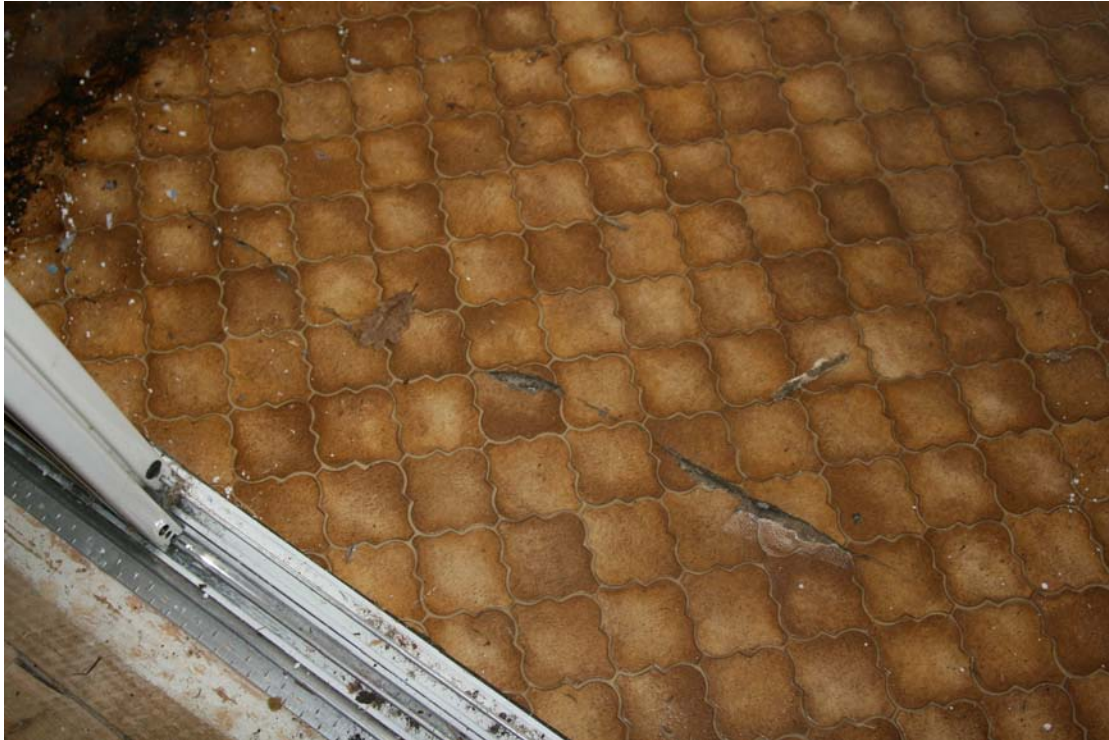
There is a solid concrete floor in the kitchen. The floor has sunk and there is a deep crack across the floor, by the living room door opening. There is also a gap between the floor slab and the skirting board on the left hand wall. (See Photograph Nos. 13 & 14). This floor should be taken up and re-laid.

PHOTOGRAPH No. 13 - crack across kitchen floor

ACTION: Prior to exchange of contracts obtain estimates of cost from builders for:-

- a) **Removing the kitchen fittings, sink unit, etc.**
- b) **Grubbing up the existing floor, removing all concrete and hardcore, as necessary.**
- c) **Laying a new floor on a hardcore base, incorporating a damp proof membrane and thermal insulation.**

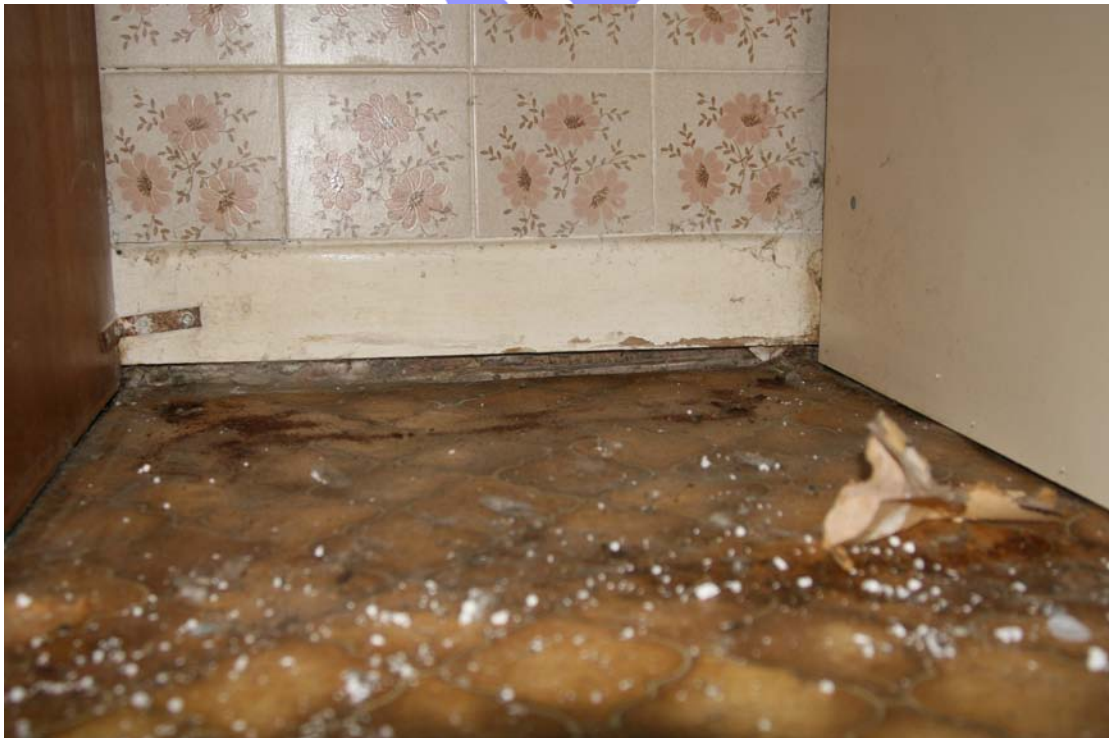
PHOTOGRAPH No. 14 - gaps between skirting and kitchen floor

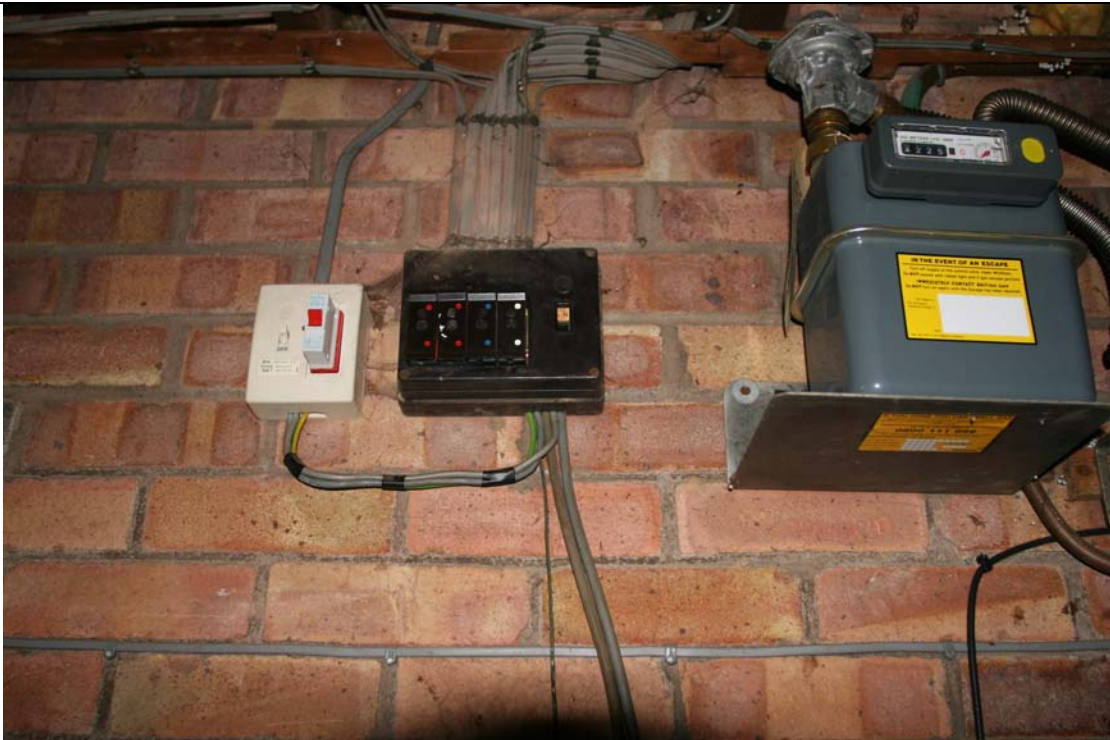
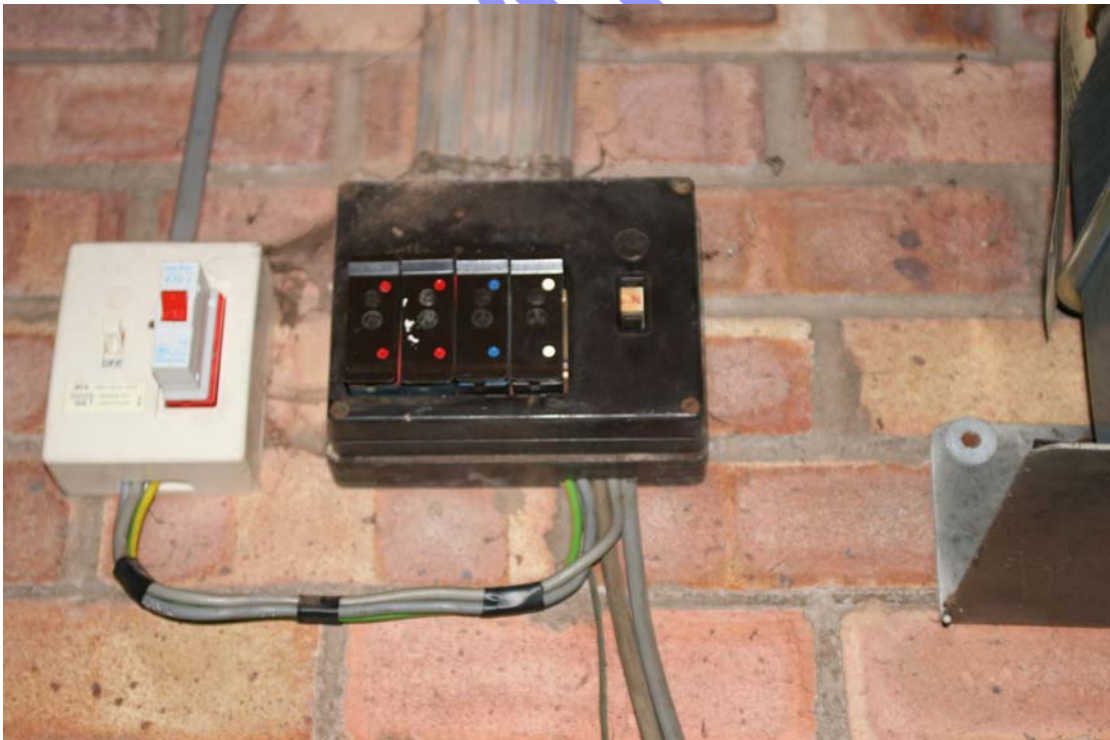
76 & 77

The electricity meter and consumer board (fuse box) are located in the garage. The mains supply connects to a wiring system of some age and one which will not comply with current regulations. The whole installation needs to be tested and checked. Re-wiring is likely to be needed.

PHOTOGRAPH No. 76 - The electricity fuse board

PHOTOGRAPH No. 77 - The electricity fuse board

ACTION: Prior to exchange of contracts, arrange for an NICEIC registered electrician to inspect the electrical installation and to provide an estimate of cost for re-wiring.
