**PHOTOGRAPHIC SCHEDULE OF CONDITION IN RESPECT OF:-  
A Light Industrial Unit Undertaken in November 2010**

The Schedule has been prepared to record the overall condition of the premises at the commencement of a full repairing lease.

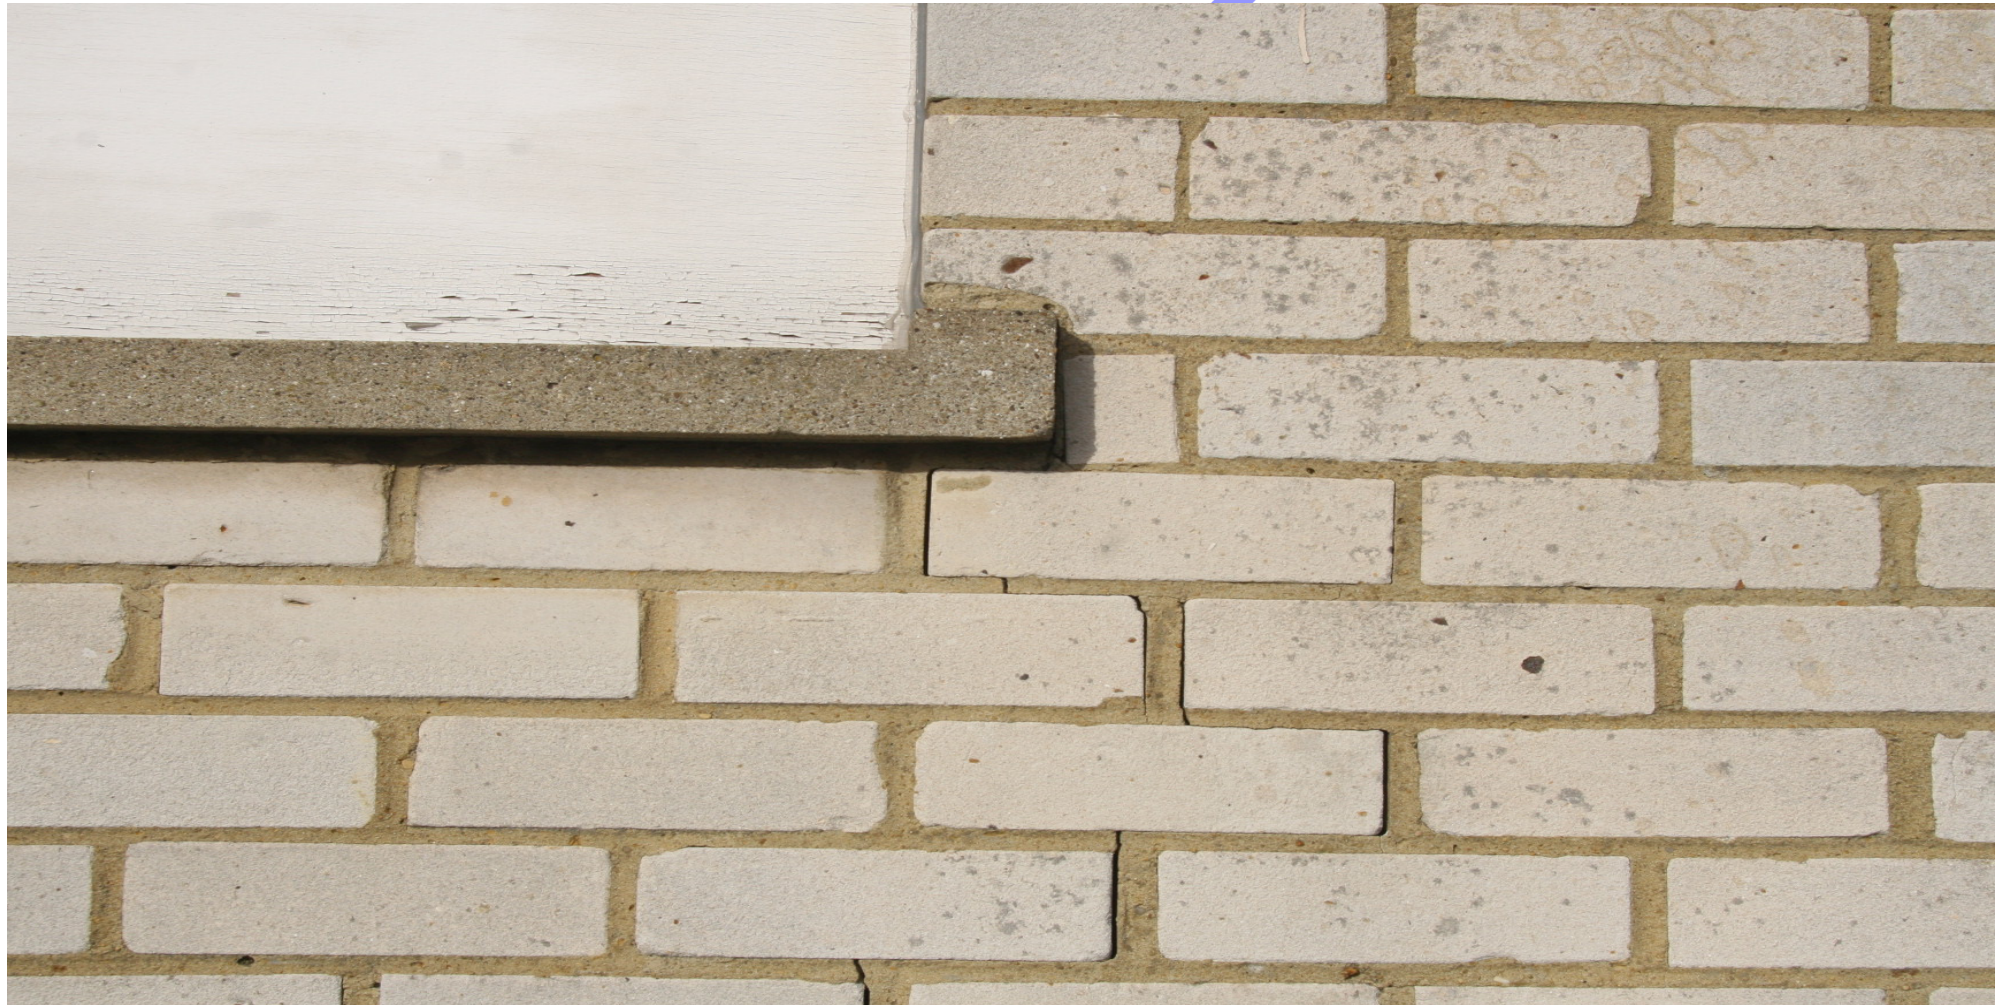
**PHOTO No. 239 CRACK THROUGH THE LEFT HAND WALL EXTERNALLY**

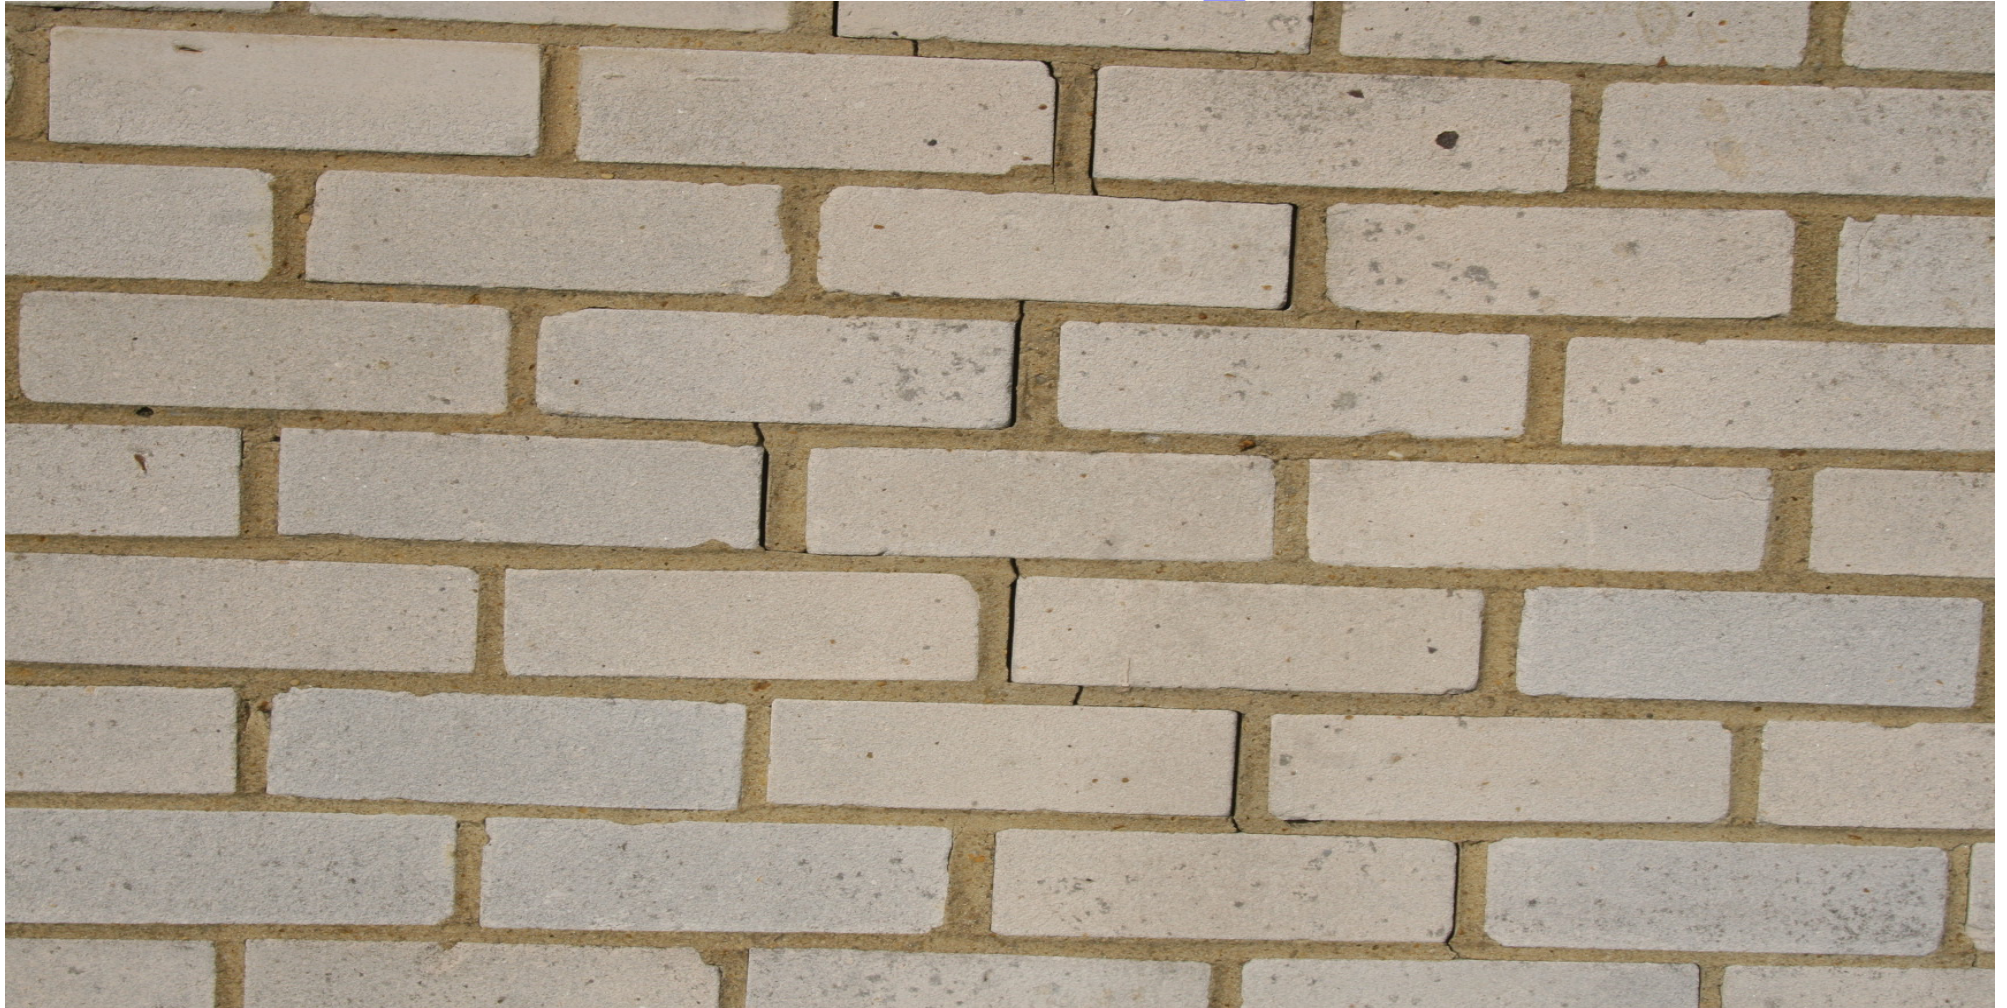
**PHOTO No. 240 CRACK THROUGH THE LEFT HAND WALL EXTERNALLY**

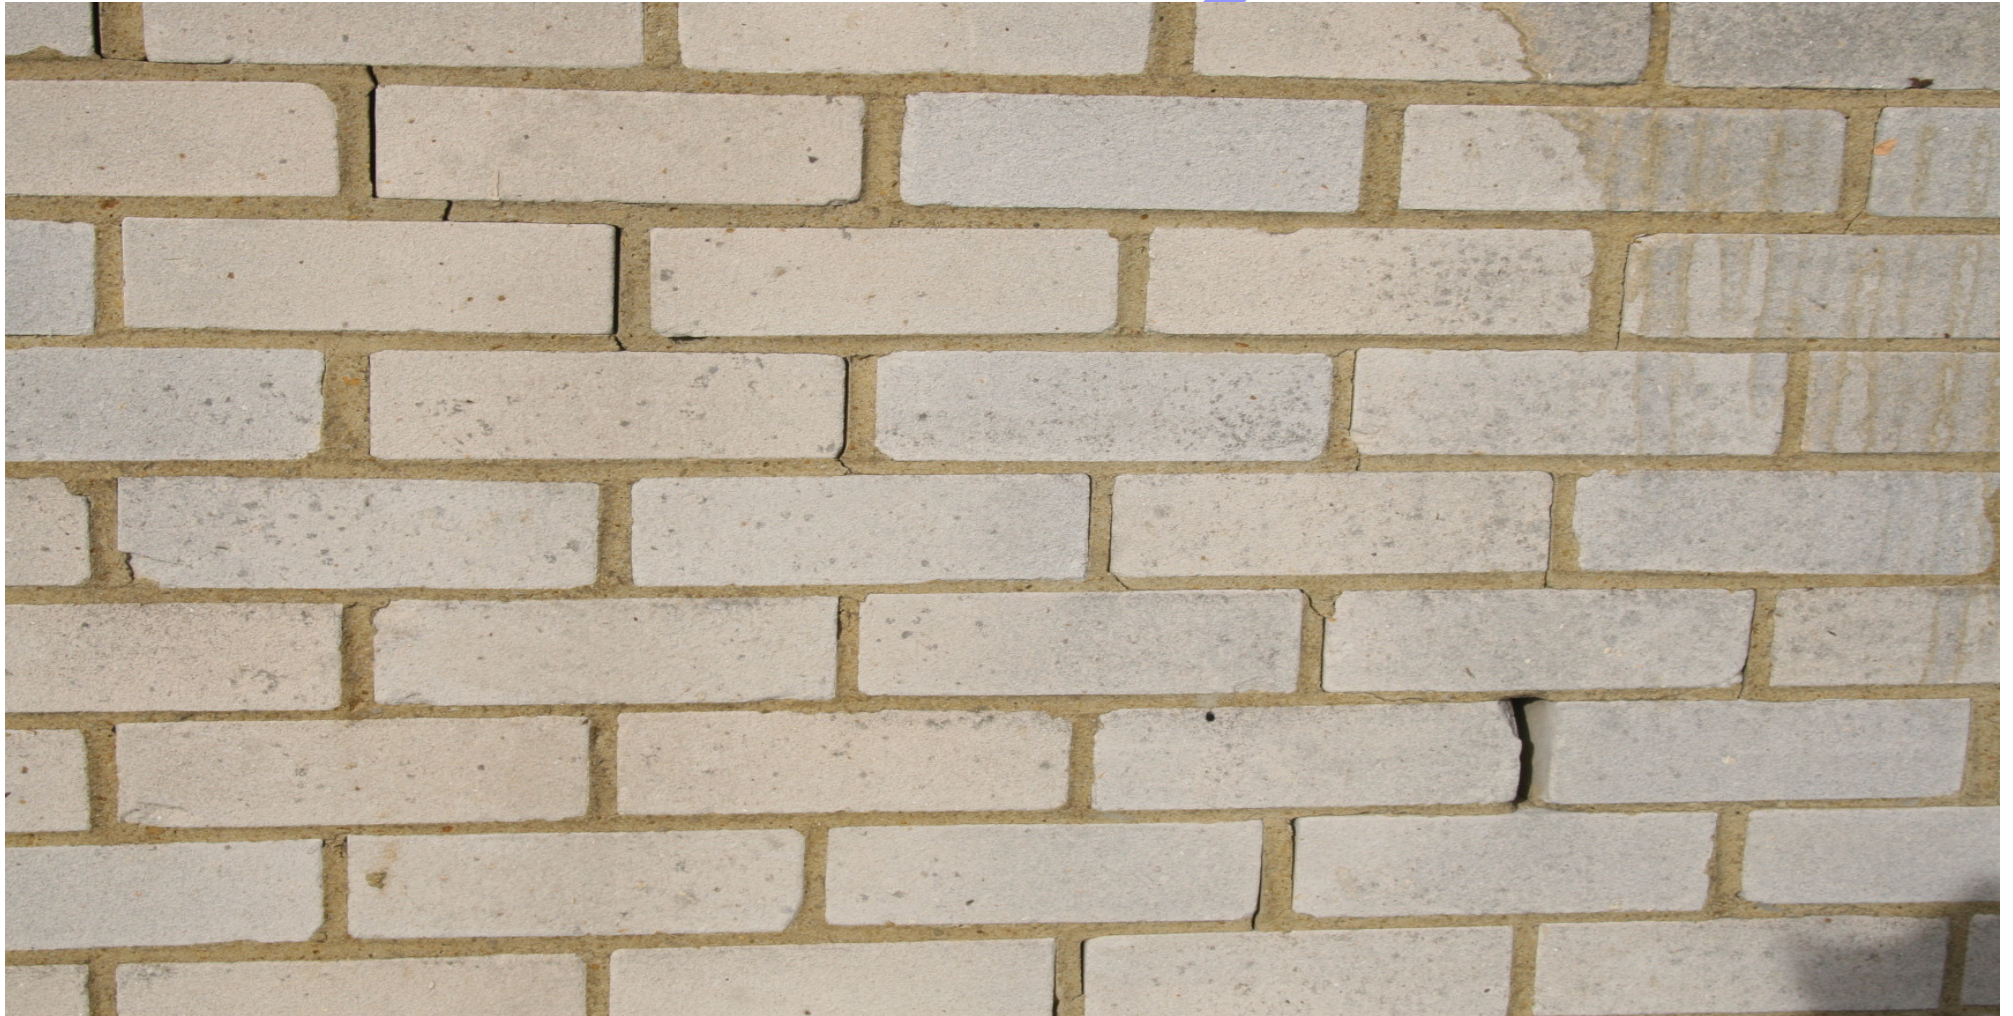
**PHOTO No. 241 CRACK THROUGH THE LEFT HAND WALL EXTERNALLY**

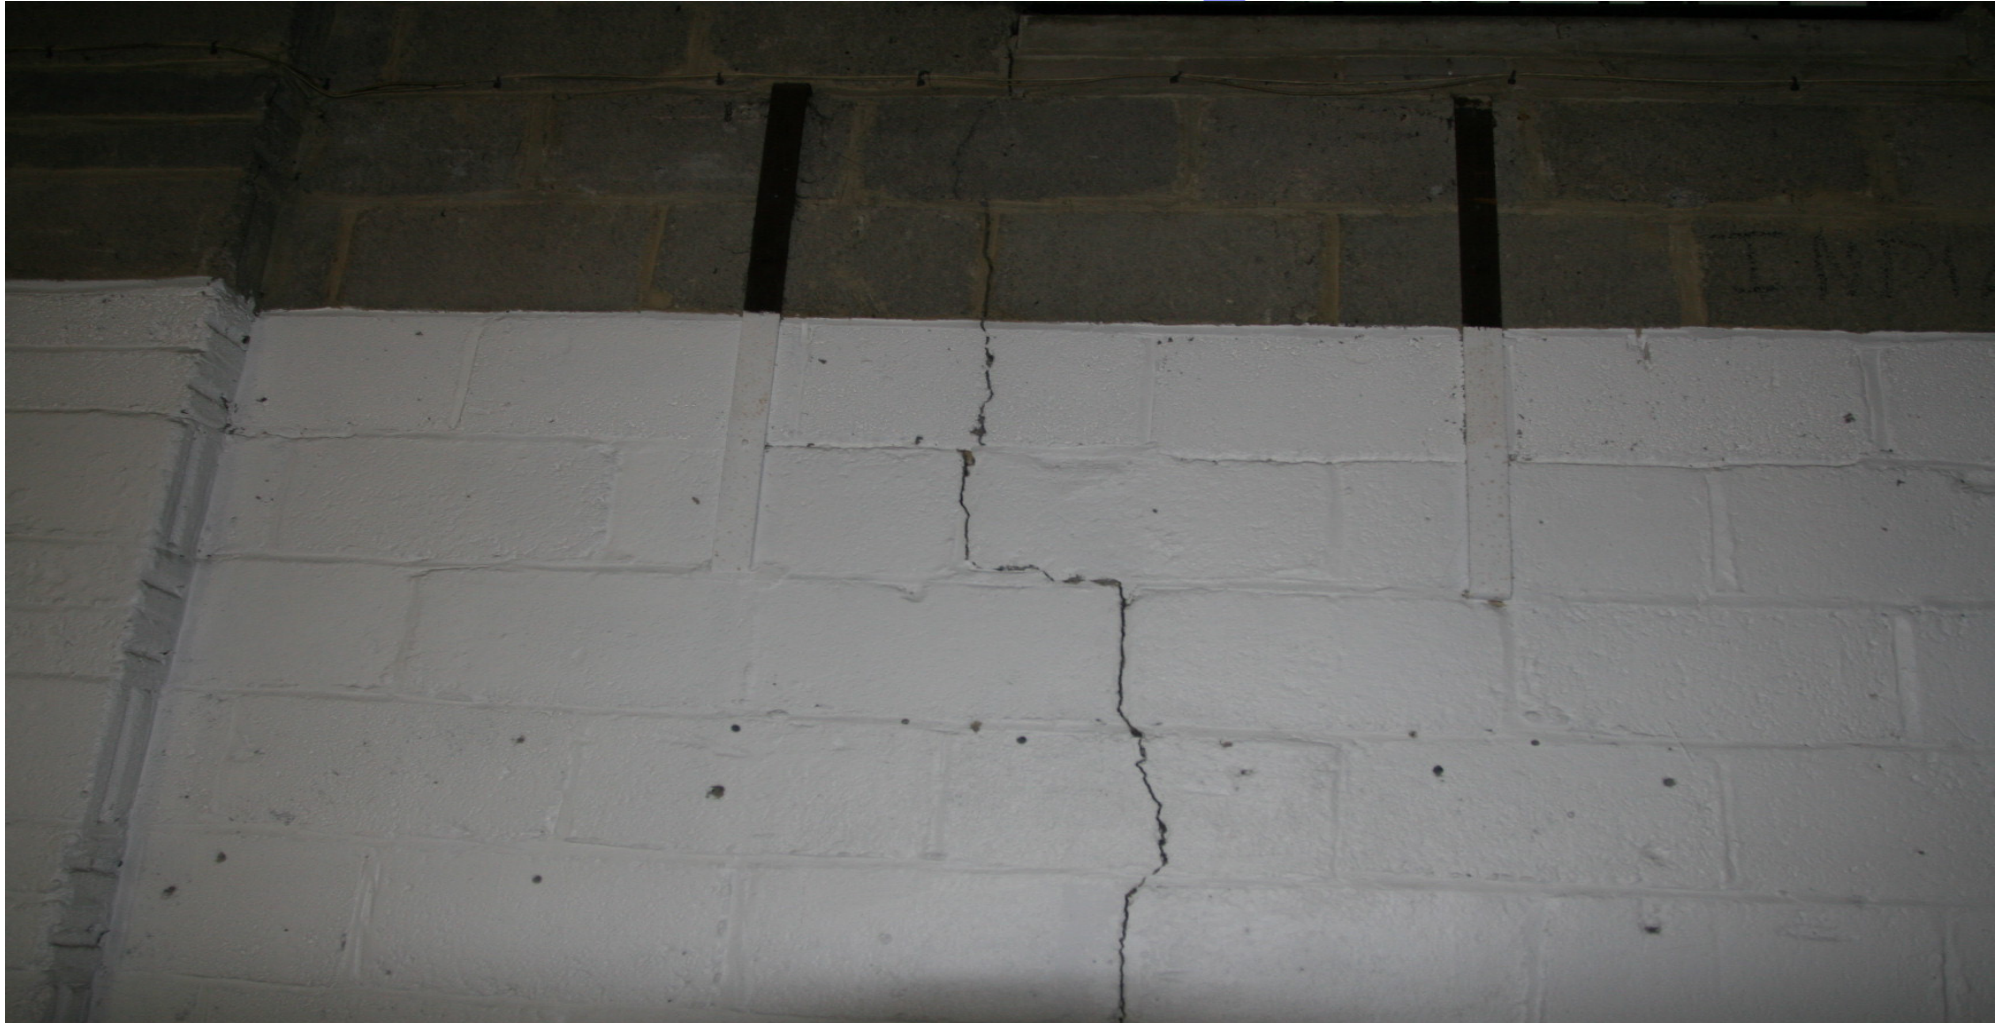
**PHOTO No. 410 CRACK THROUGH THE LEFT HAND WALL INTERNALLY**

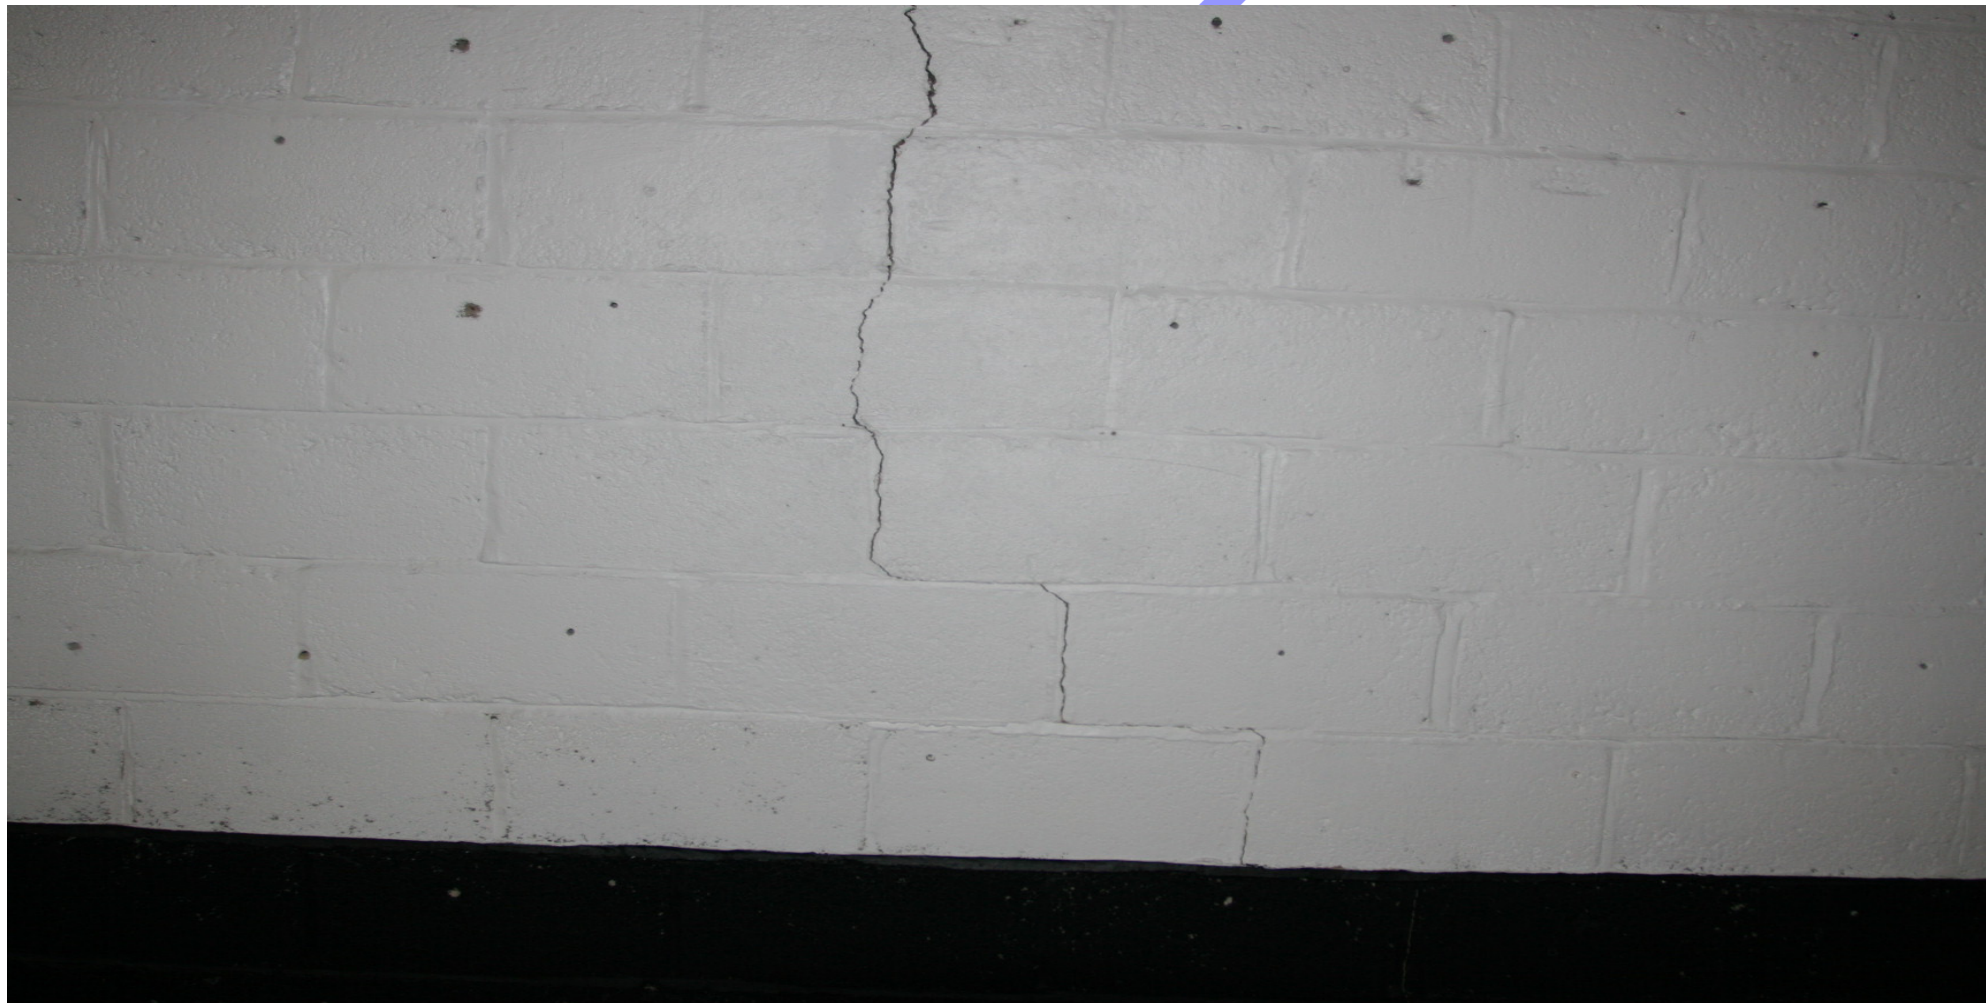
**PHOTO No. 411 CRACK THROUGH THE LEFT HAND WALL INTERNALLY**

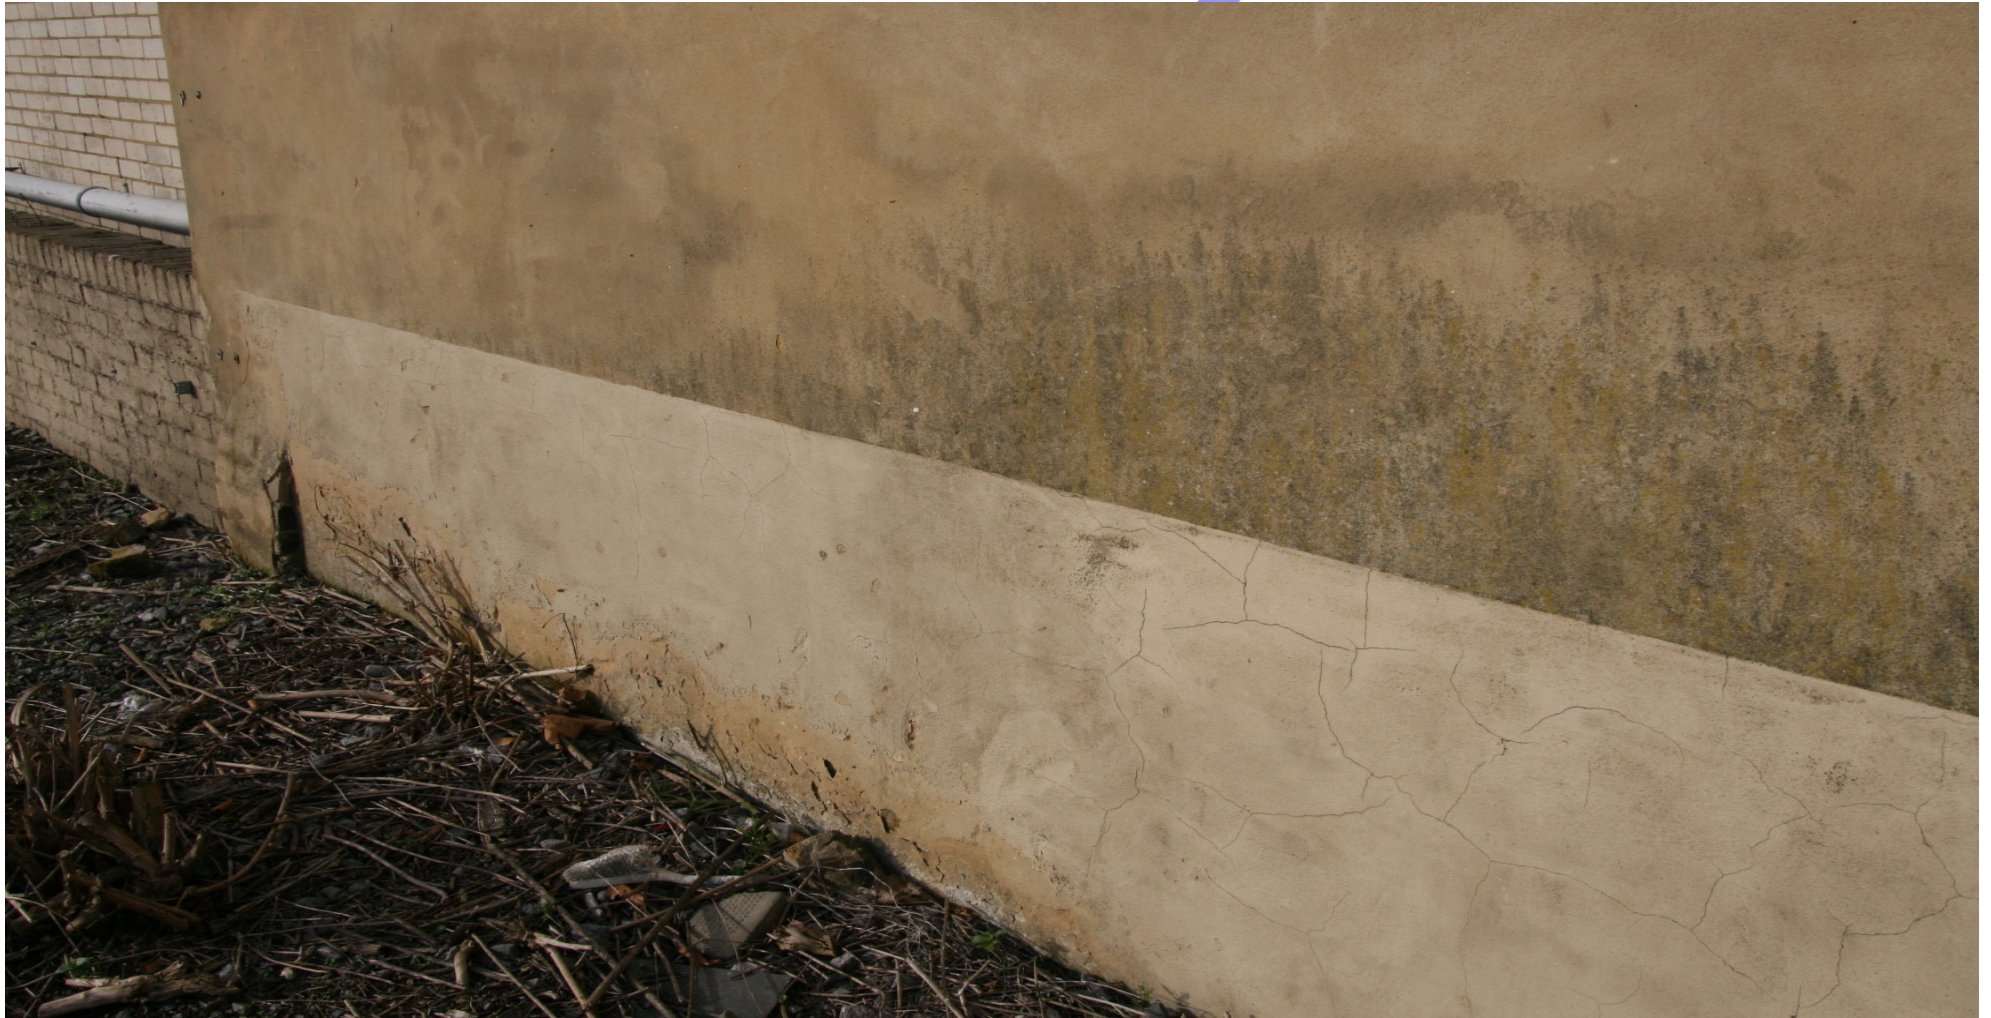
**PHOTO No. 263 CRAZED AND LOOSE RENDER ON THE LEFT HAND WALL EXTERNALLY**

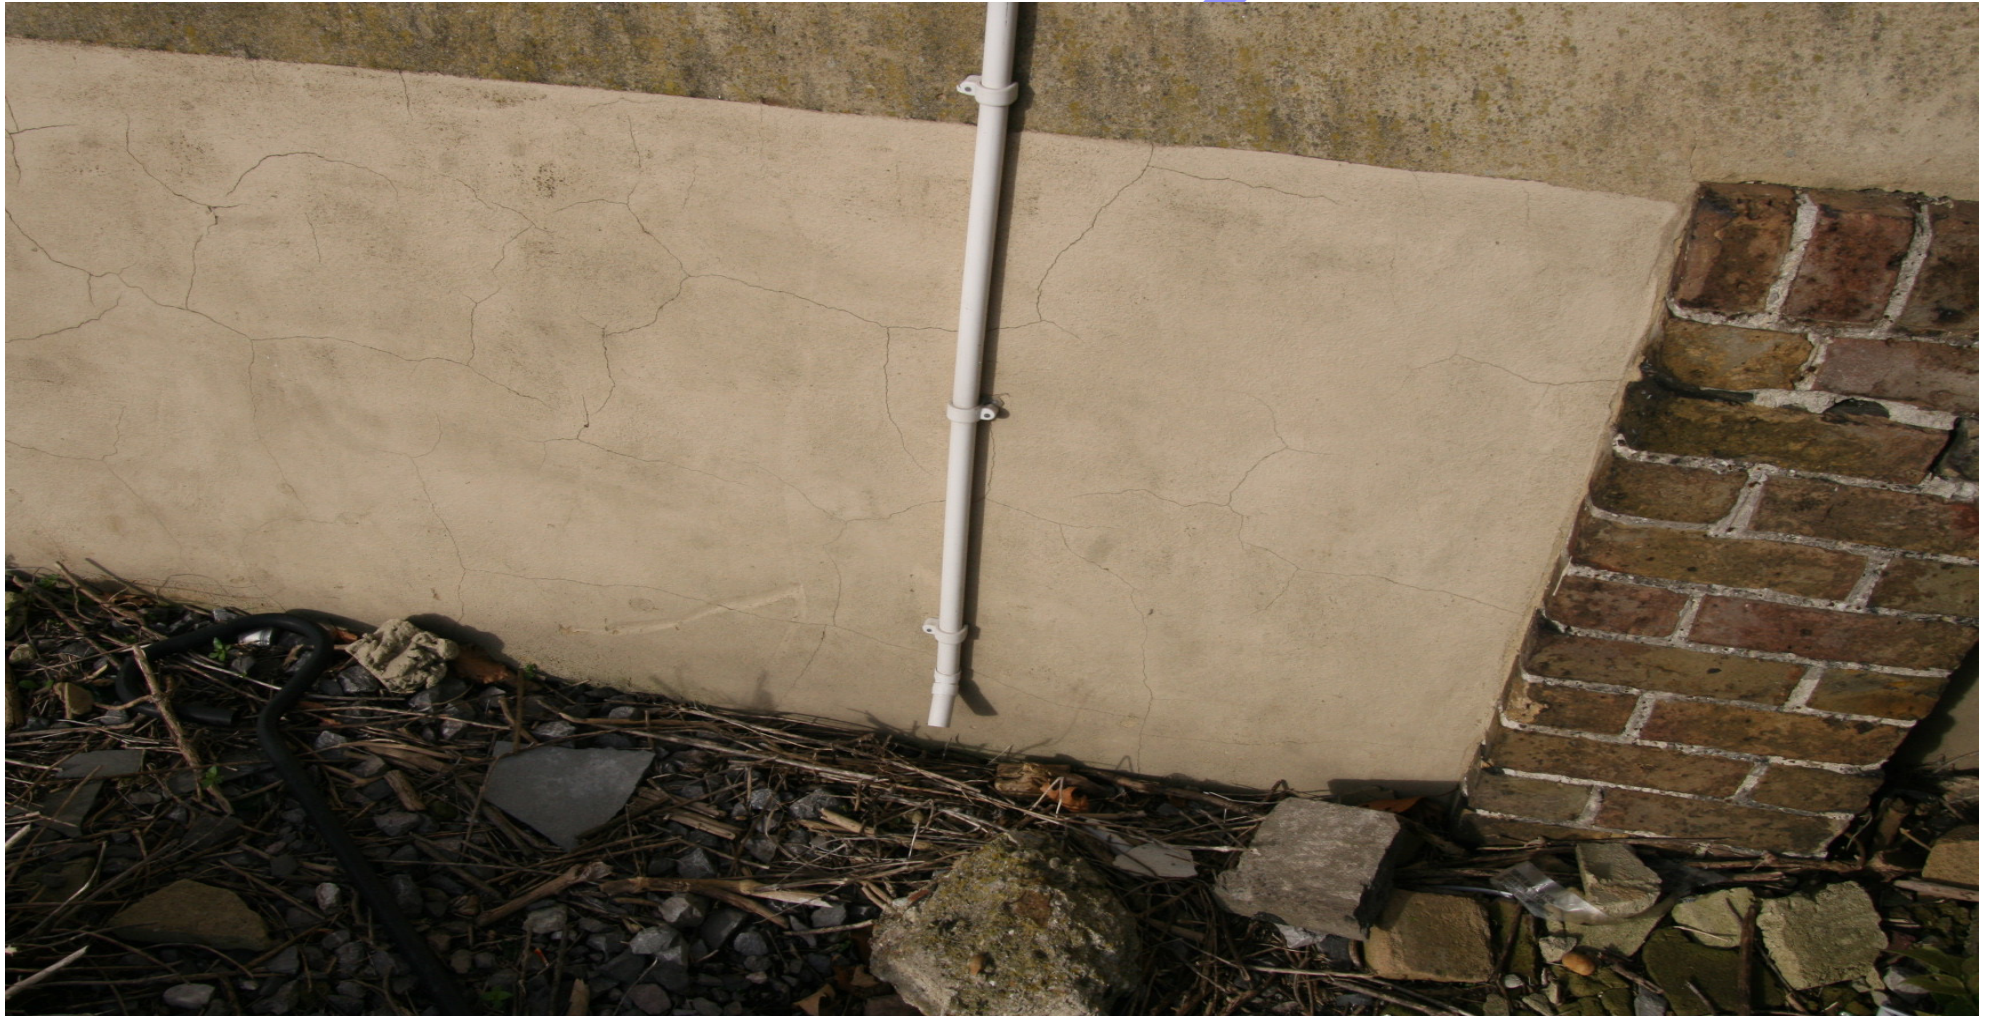
**PHOTO No. 264 CRAZED AND LOOSE RENDER ON THE LEFT HAND WALL EXTERNALLY**
